ANCIENT SUKARA NIJJARA DAM OF THE RIVER – DEDURU OYA IN SRI LANKA

– Chandana Rohana Withanachchi

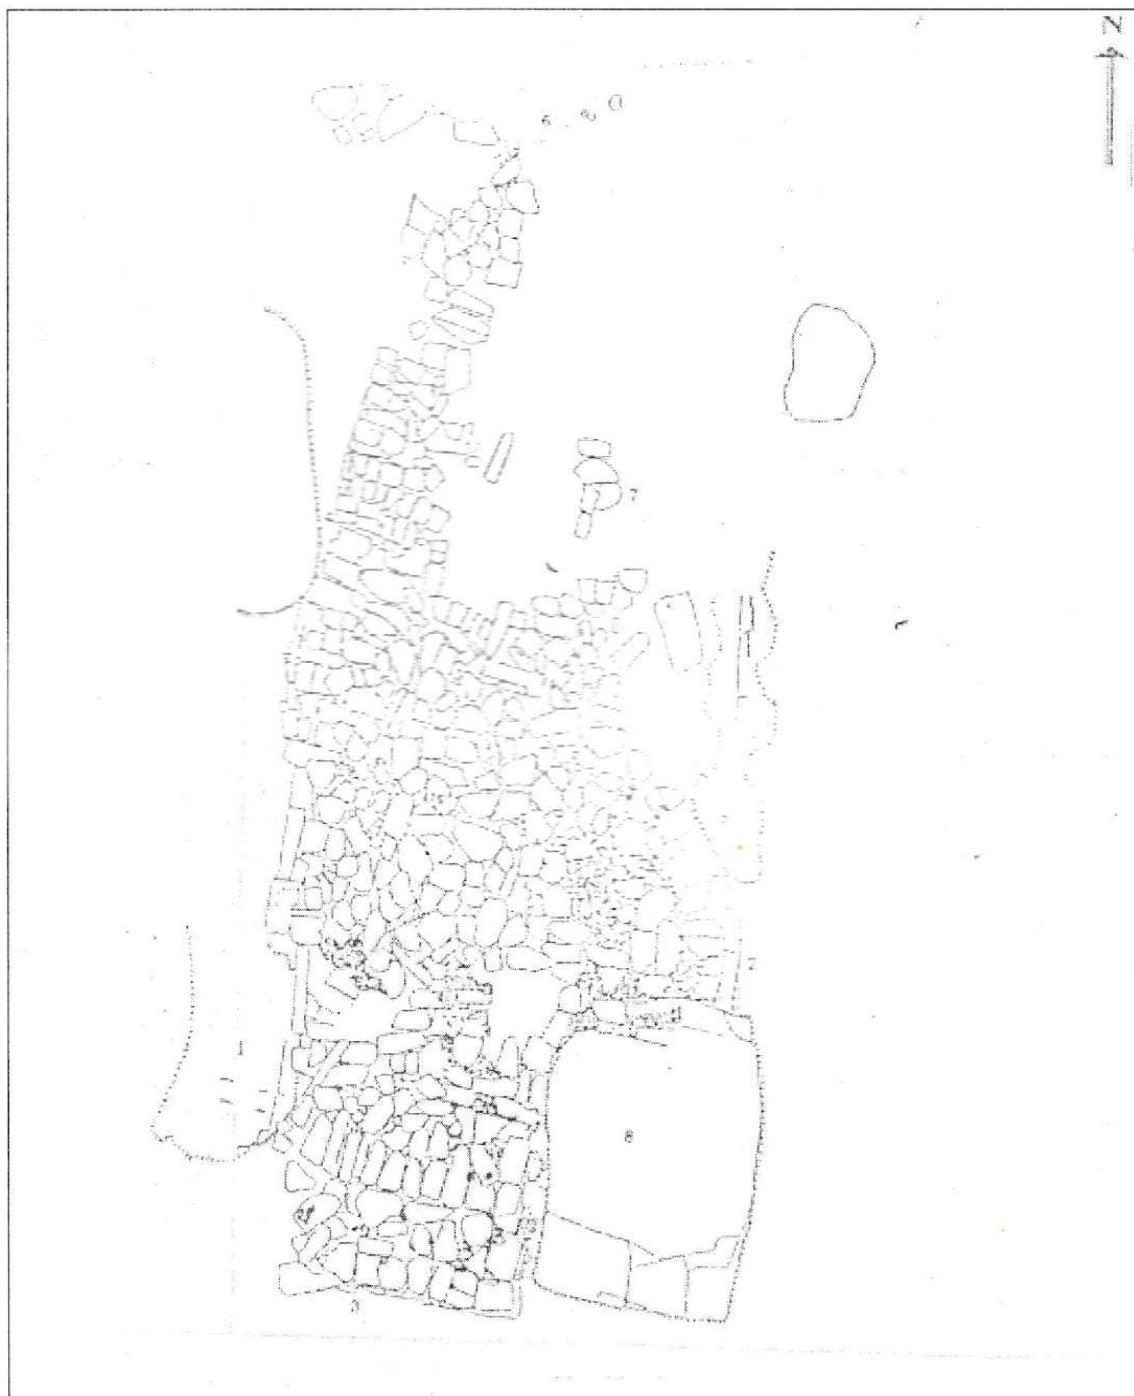
Plan No. 1

Ruins of the portion of right end of the dam (Plan No. 1)

It seems that the remaining ruins of the right end portion are built on the natural rock plane. The method of the linking stone blocks each other for constructing the dam is clearly shown on the rock plane close to the river. Here, the stone blocks are fixed in to the cuts, made on the rock plane. These cuts are in the length of about 1.40 metres.

40% of the typical stone blocks lying on the natural rock of the lower part of the right portion, can be seen protected in their first form it self. The bottom layer of this portion is totally well protected, But the top layers are greatly changed from their initial form, resulting natural disasters such as floods, root pressure of different trees and human activities etc. Hence, only about 5% of this portion, considered as the top layer of the dam, is remained by this time.

The height of the remaining part of the top layer can be considered as it's maximum height. It is of about a 3.90 metres height above the river base. According to this the maximum height of the dam seems to be nearly 4.00 metres.

The upper and lower parts of this portion are made of well made rectangular and square shaped stone blocks, but for the mid portion, only imperfect stone blocks have been used. Mostly, there are stone blocks in various shapes spread over the layer, so as to make a levelled surface and to fill up the inter spaces, the tiny pebbles have been fixed and for some places, a strong lime plaster has been used.

When consider the ruins of upper part, there is a rock profile facing the East direction by which, one can get knowledge of making the front section (The side, facing water) of an ancient dam. This part is built by using splitted and well shaped, long stone slabs on the natural rock place, and it is placed within a large rock beside the river and a rock plane of the right direction. There are ruins of six stone layers in this place and these, the stone blocks are fixed each other, by deep cuts to prevent them moving off. The large rock mentioned above, is taken to help to build strongly the upper left end of the right portion of the dam. The cut marks and remaining plaster of this place prove that, the rock layers had been fixed, in to this rock. This method of fixing makes the strength of a dam. Besides this place, an area of about 25 square metres is covered with a layer of lime plaster composing more particles of quartz.

Surface plan of the southern section of the Sukaraniijara Anicut

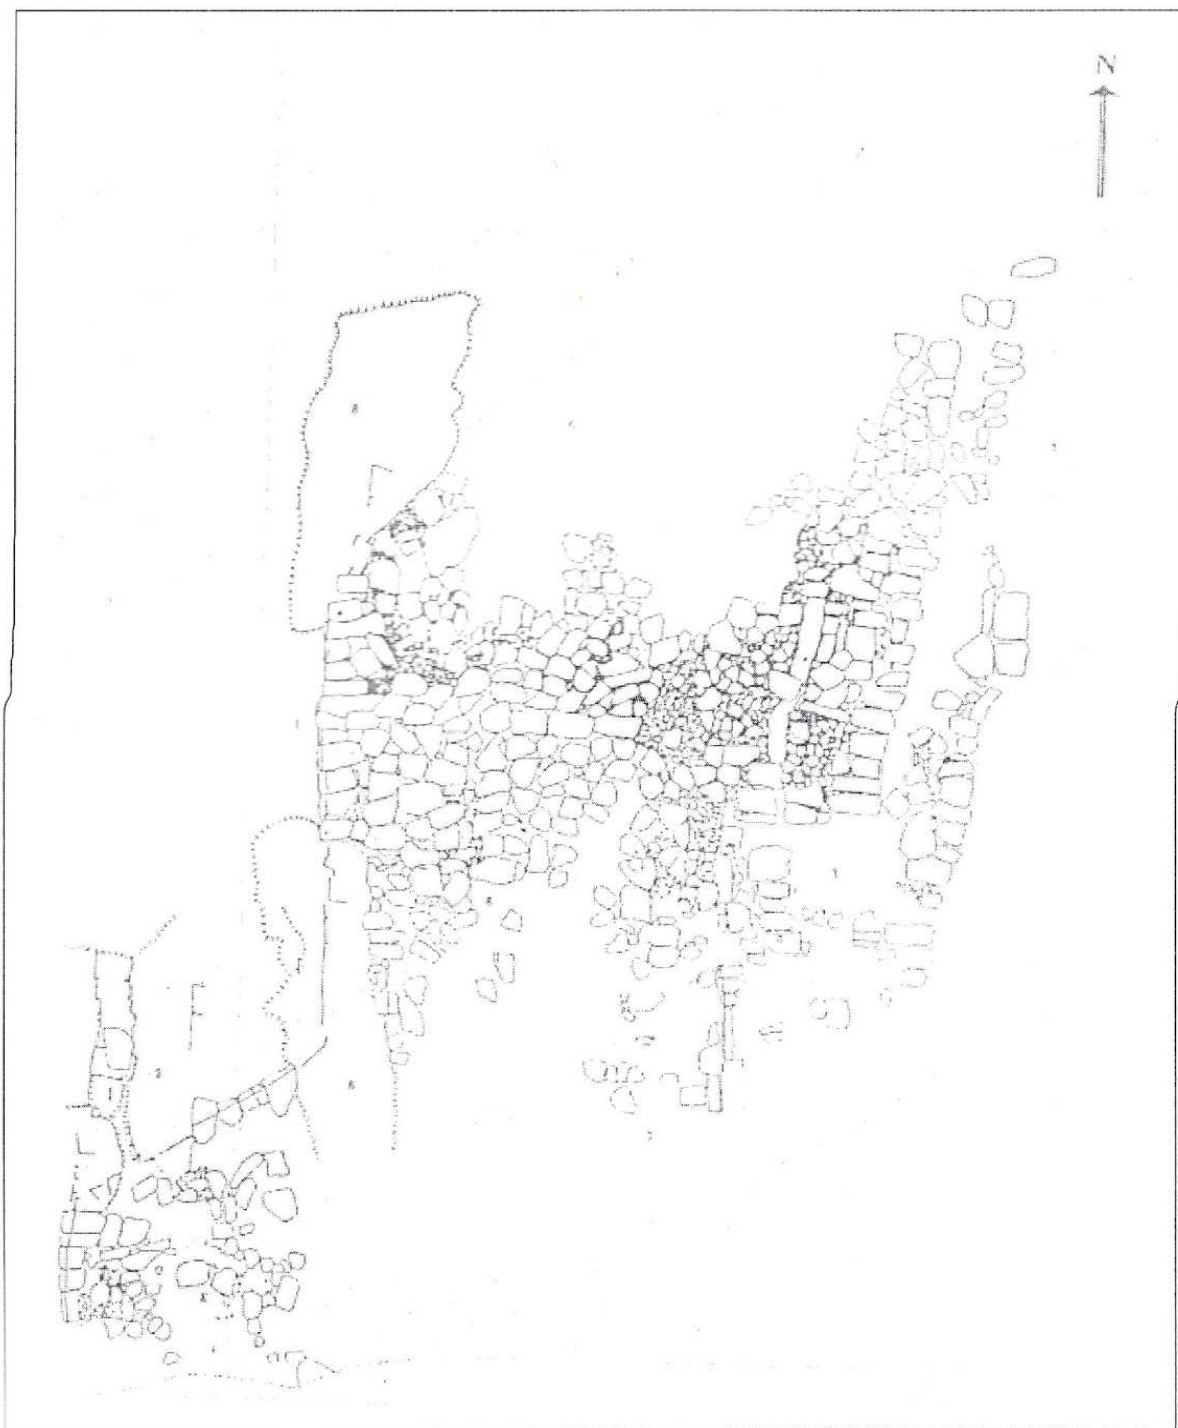
Plan No. 2

Ruins of the portion of left end of the dam, (Plan No. 2)

In this portion, lying on the left bank of the river Dedura Oya, there are only remains of several rock layers in it's lower side. This is also built basing a natural slopy rock plane running from left bank towards the river direction. the remaining rock layer of this portion is in a height of about 3.38 metres in comparison with the maximum height of the dam. In the down part of this portion, near by mid-river, there is a part of side bund still remained. This can be decided as the last lower limit of the dam. By the cuts of rock plane and the stone blocks, they are connected with one another. There are remains of only three stone layers to identify, but in comparision with the maximum height of the dam, it can believe that another five layers must have been had, over these layers. It is identified that mostly the lime plaster had been used to fix the stones each other in this part-specially in the places, where the stones were unable to fix with the natural rock by rock cuts. It seems clearly that, to prepare this plastering mixture, they have used not only quarts particles but also the small pebbles too. This strong plaster can be identified even now very clearly.

There is cut mark, as a single line runing ahead, in the natural rock plane of the lower end towards the left side of the river. After a 5.50 metres length from the starting point, this cut line turns in an angle of 140° , to the South West direction from the outside of the dam. This cut line is marked also on the large 4 stone blocks lying at the end of the cut line. this cut line ends near a large natural rock, close by riverbank. This clears the efforts of fixing the bund of the dam, by turning it in a

140° angle, with the natural rock of the left bank. This device helps, to stop the sliding of the dam down by the pressure of flowing water from the upper side. There are identified ruins of some another stone layers in this place.

The place where the bund of left part of the dam, had been fixed with the riverbank, is severely damaged, so that it is difficult to understand its initial structure. The special mark of this place is the bricklayer, that is lying close to the bank. This is the only place, where there is evidence, to prove that the bricks had been used to build this dam. There are eight brick layers, laid upwards, on the ground surface. This is typically constructed by using lime plaster and neatly keeping its inter-spaces. The size of a brick is 23x11x4 centimeter in the length, width and height. This bricklayer proves that it had been fixed in to the left bank. So it can be guessed that bricks had been taken in to use when joining the dam with the riverbank.

There are another trench shaped important cut marks, just below the dam in this part. They give an understanding about another constructional technique of a dam. These cuts, of about one metres distance to each other, give an understanding that there had been put up a stone layer on the ground surface. This portion is very close to the bottom of the dam and it is 3.50 metres below the maximum top height. According to this, it is clear that, by this constructional device, the dam had been given a good protection to stop the erosion, in the places where there was no any proper condition of the stone layer, to prevent the erosion by falling water from such a height.

Surface plan of the Left Section of the Sukaraniijjara Anicut

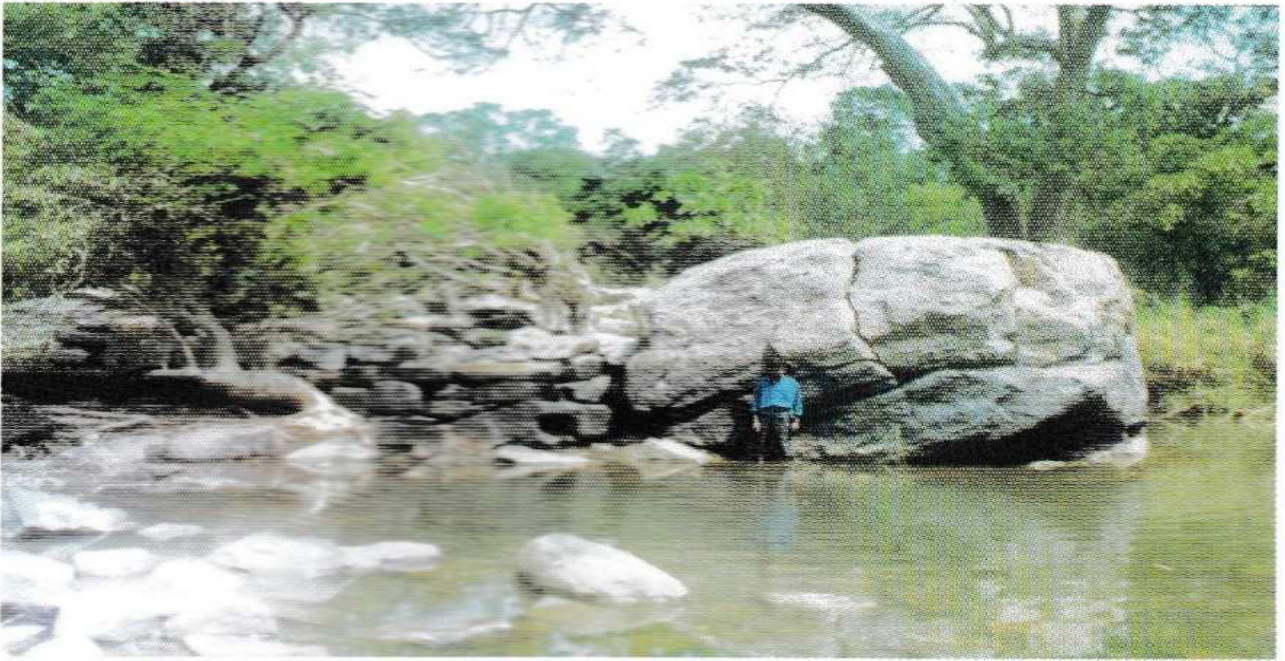
Cross section towards Oya

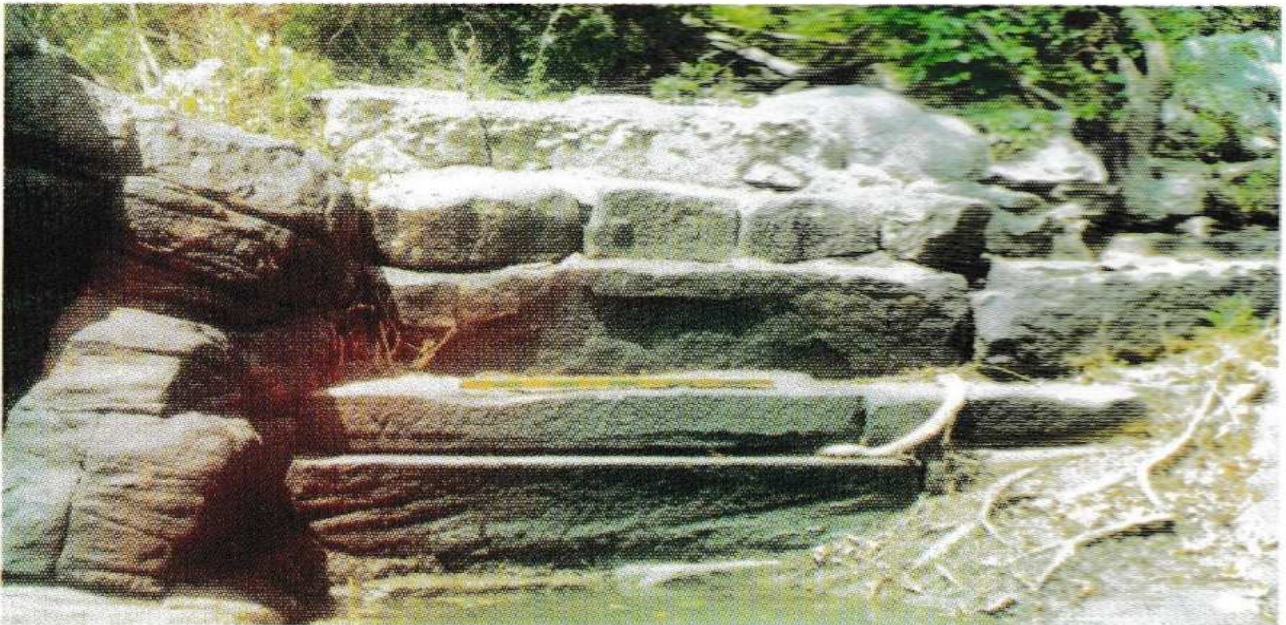
Upper Southern section of the Anicut

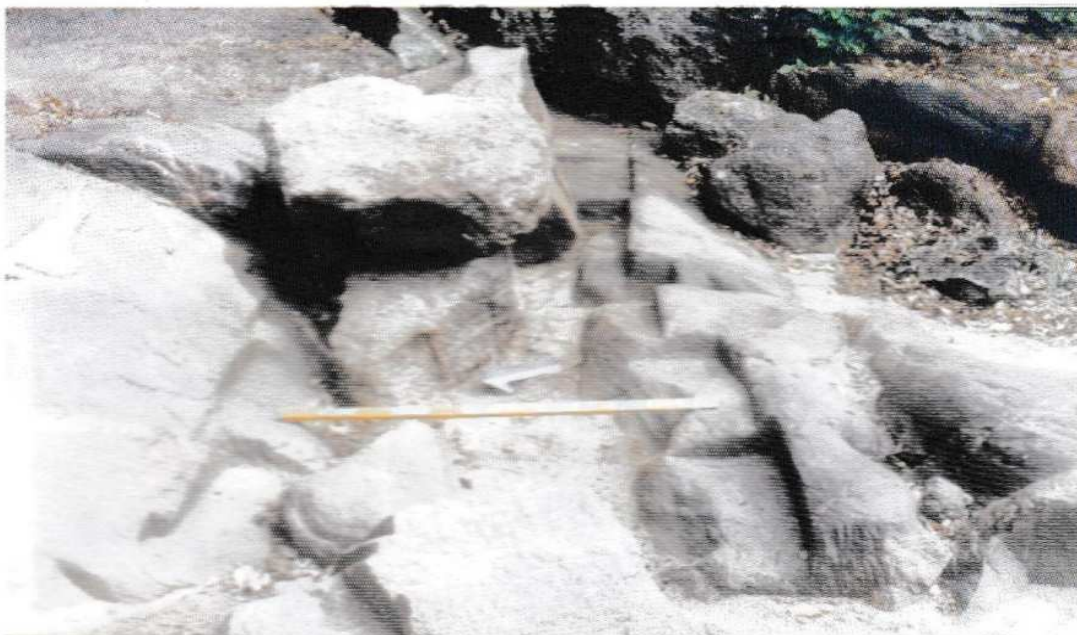
Rock cut mark of the left section

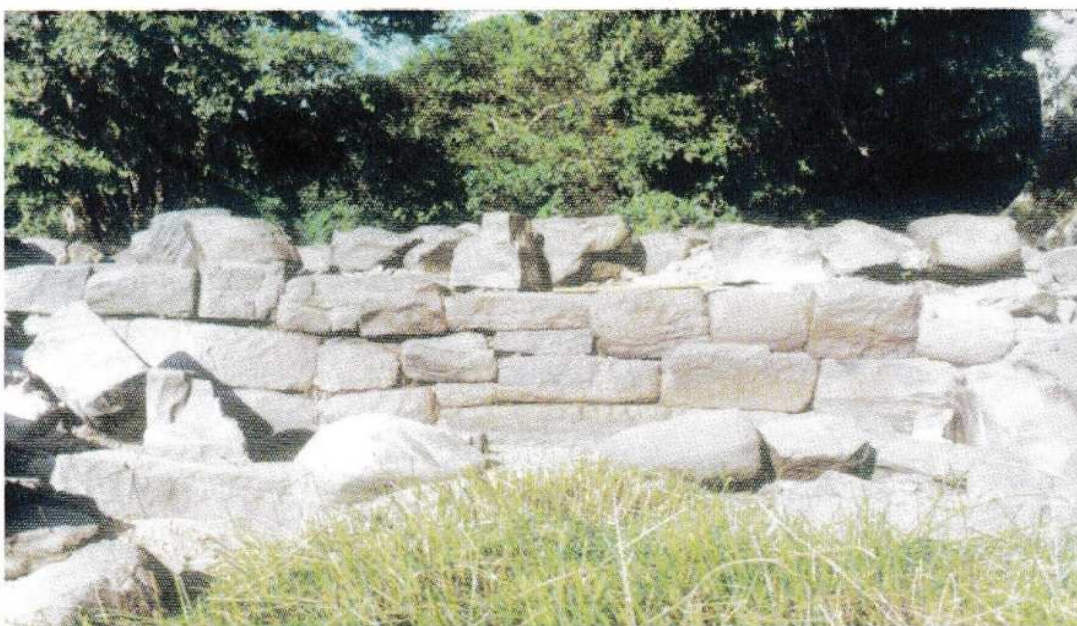
Section of the Lower end of the left part

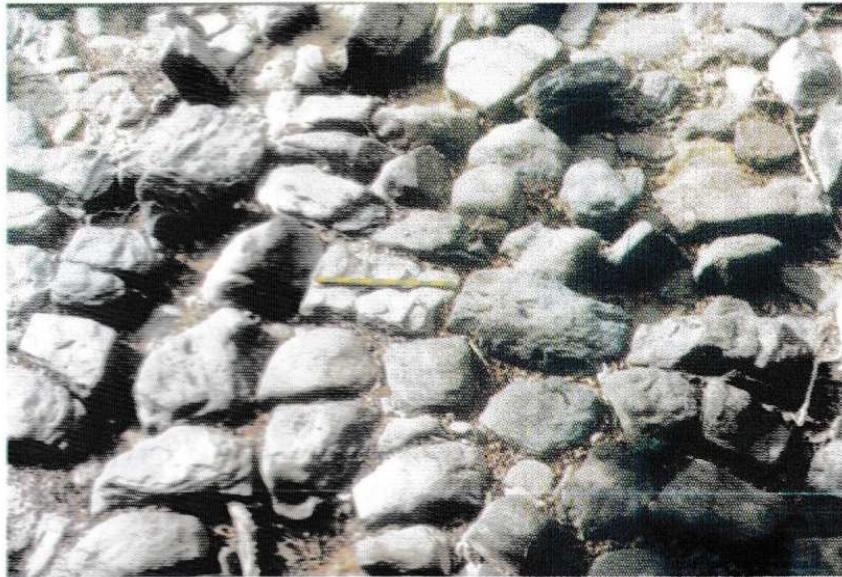
Surface of the left section – Arial view
